## Technical Notes by Dr. Mel

January 2005

### TRI Solutions For Common Problems of Extension Shafts, Oil Pumps and Steady Rest Bearings For Westinghouse Large Steam Turbine Generators

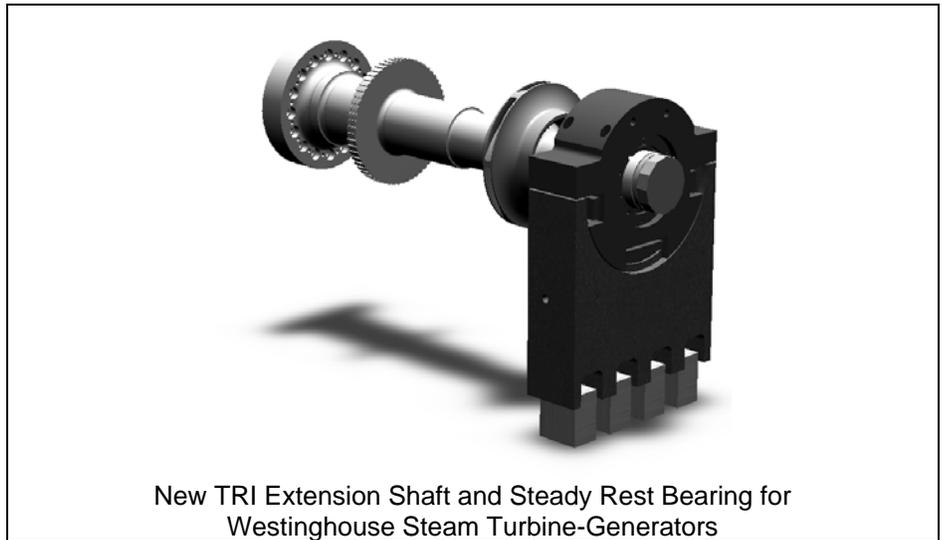
New TRI Extension Shaft and Steady Rest Bearing for  
Westinghouse Steam Turbine-Generators

When no steady rest bearing exists, the preferred solution is to replace the existing extension shaft with a new TRI extension shaft and install a very substantial steady rest bearing at the outboard end of the extension shaft. The TRI Align-A-Pad® Bearing has proven to be an ideal solution.

When a 4-pad Westinghouse steady rest bearing already exists, the preferred solution is to replace it with a new TRI Align-A-Pad® design.

The TRI Align-A-Pad® Bearing for this Steady Rest application has 5 tilting pads with heavy duty pad support contacts. A new heavy pedestal is included in the design, which can be modified to extend down to the floor of the front standard and/or attached to the front wall of the front standard. The bearing is equipped with 3 “saddle blocks” or alignment pads to align the bearing relative to the new heavy pedestal. This TRI solution has been in service for over 10 years with very low vibration and almost no maintenance.
