Technical Notes by Dr. Mel

June 2019

HYDROGEN SEALS AND TILT PAD BEARING UPGRADES

How to improve aging GE Large Steam Turbine-Generators

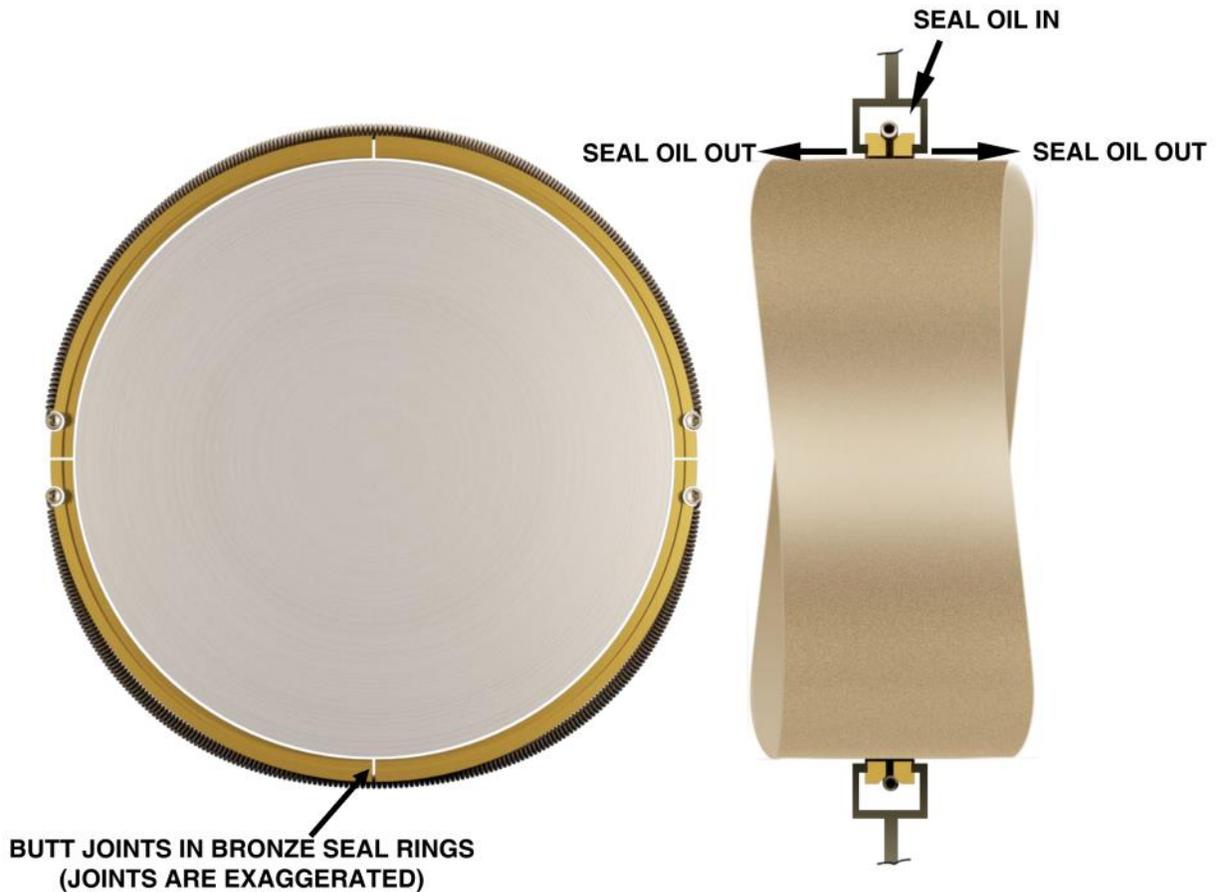
Many GE Generators in service today use hydrogen seals that were developed in the 1930s. The seals consist of four 90° bronze segments that are held in place by garter springs. Pressurized seal oil pushes the two rings axially and in opposite directions making face seals with the housing. With this design, there were many areas where hydrogen leaks can develop:

- (1) At the "butt" joints between the ring segments.
- (2) Between the faces of the seal rings and the faces of the housings.
- (3) Through the static joints of the top and bottom halves of the main seal housing.

Given that Hydrogen cooling is here to stay, the question is: What can be done to improve the H₂ sealing process? In an ideal world, the GE hydrogen seal design should work reasonably well. In practice, the quarter-segment seal rings do not stay seated at the "butt joints", particularly if there is significant rotor vibration or if the seal ring housing is not centered on the rotor.

The hydrogen seal ring design used by TRI has 360-degree steel and Babbitt rings with bolted joints. Access to the rings is achieved by removing only a small top half housing and the main housing stays in place. "Hook" fits on the seal rings are gone, so these seals can easily be removed and inspected or replaced if necessary. Improvements to the design, materials and manufacturing keep the TRI hydrogen seal bores round and the joint gaps closed.

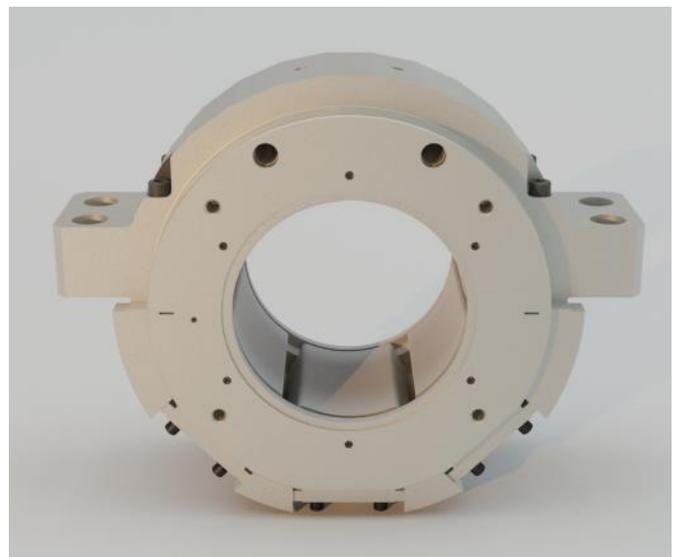
The 6-pad "classical" design

In many cases, the pad backs have worn a pocket into the bore of the housing. The pads and housings are made of very soft steel, and inserts have been made to fit into the back of the pads, not

particularly the bottom pads. The top pads usually have a bar of soft steel across each pad to be used to adjust clearance.

In other cases, the bottom three pads have had bars installed that resemble the bars on the top pads, and these have been hand rounded so that they have a double curvature, but not a curvature that is sufficiently correct to produce the desired rolling function.

A problem with bottom pads that have had a slot cut for a bar is that this greatly reduces the bending stiffness and strength of the pad for supporting the oil film with a heavy load. TRI can offer other viable options, if time to obtain other materials exists.

Preferred options include making pad rings of heat-treated alloy steel and installing round inserts

of similar steel in the top pads for clearance adjustments. Another variation is to install round inserts of heat-treated steel at all pad locations to resist wear.

In any of these cases, the preferred choice is to machine the backs of the pads with a proper double radius shape.
