Transmission
& Bearing Corp.

Technical Notes by Dr. Mel

Cracks Found, and to be Found, in Westinghouse Cast Steel Bearings
with Conclusions and Recommendations for Resolution

Cracked Bearing Castings

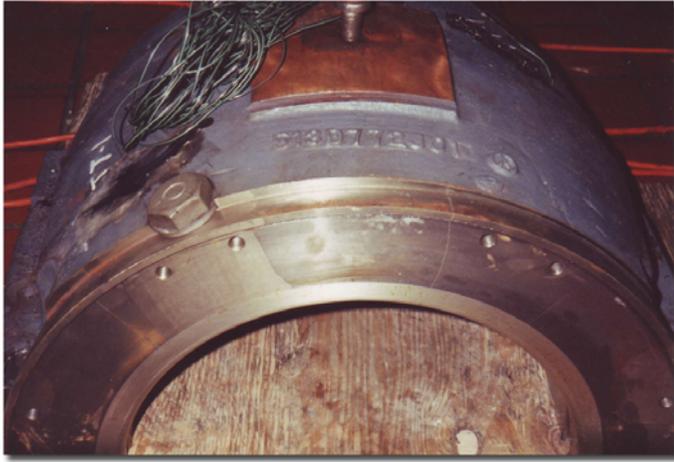
PHOTO 1

The first time that the subject of cracking of cast Westinghouse bearings came to the attention of TRI was in 1996. A 16" diameter generator bearing was found to have cracks in an axial face, Photo 1. There is nothing that can be done to repair cracks in such a bearing operating in this environment because there is no certainty of permanence.

TRI manufactured a replacement bearing using a forged steel ring made of AISI 1030 steel. The customer specified that the bore geometry be an exact duplicate the original circular bore including the overshot oil spreader groove in the axial center of the upper half. TRI manufactured this bearing as specified, Photos 2 and 3. The Babbitt thickness that TRI uses is a thin layer, approximately 0.100 " per side.

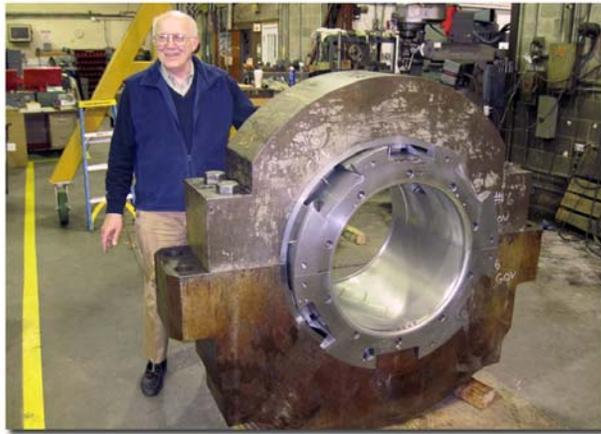
PHOTO 4

TRI proposed new bearings that would have a series of improvements including using forged low carbon steel instead of cast steel due to improved material qualities, thereby eliminating the possibility of cracking such as has been experienced in the industry with cast iron and cast steel bearings. One of these bearings is shown in Photo 4 mounted in the supporting yoke.
